Results of corrosive depositions on super-heater pipes

Author: Joseba Moreno, Eva Miller, Max Schmid

Date: 08 February 2022

ACT2 NEWEST-CCUS project No 299683

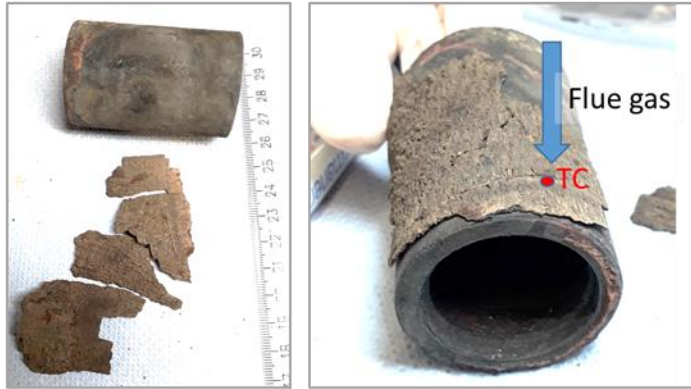
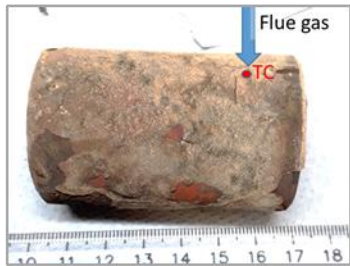
Figure 4 shows the samples after removal from the cyclone. The specimens show strong corrosion characteristics. The deposit has completely split off during the air combustion case. In addition, the sample collected during the OXY28 case shows clear corrosion even after 50 min of exposure. The split-off depositions were reconstructed on the material for photography, embedding, and analysis.

Figure 4. Overview of samples after removal of combustion chamber

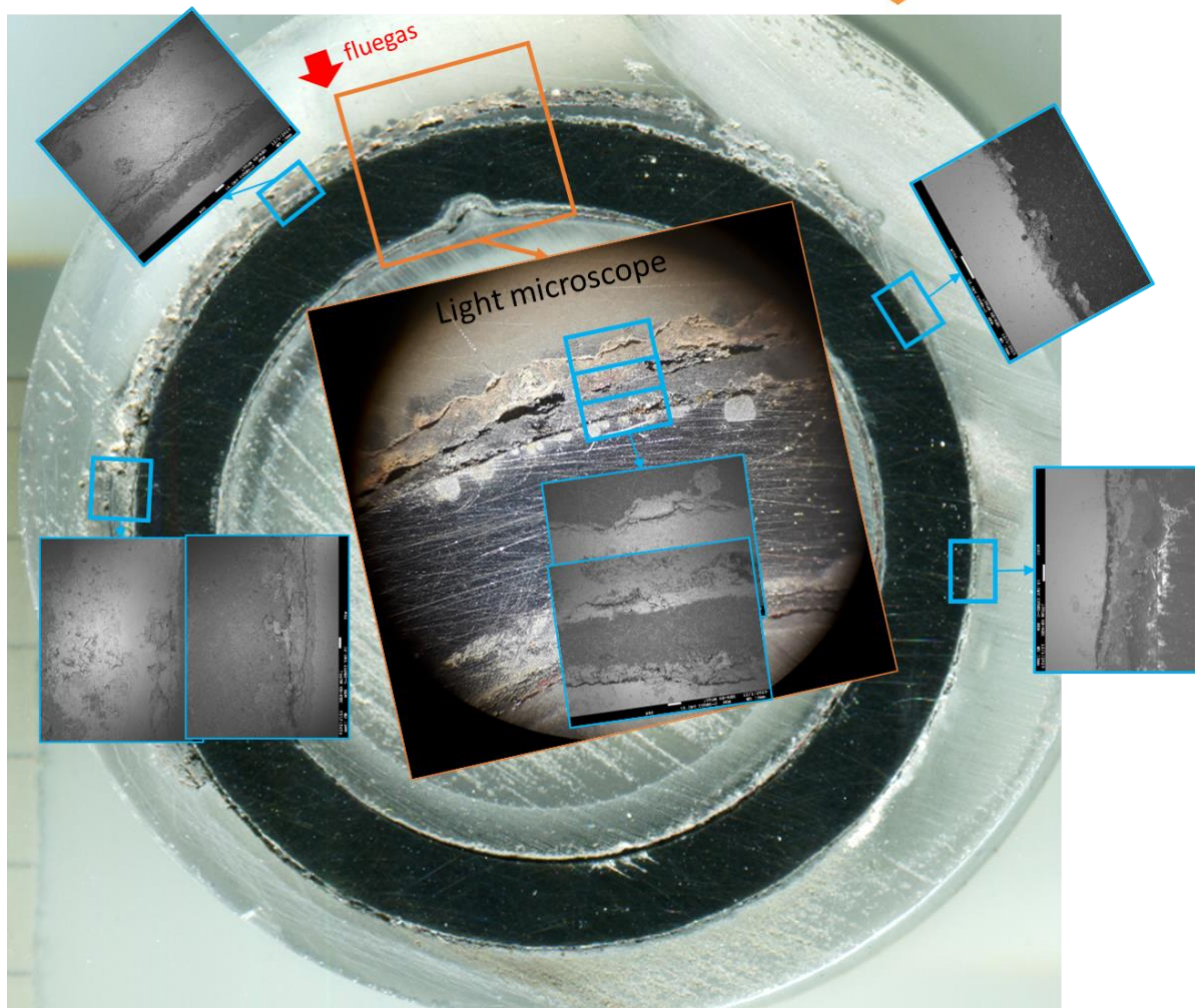
Figure 5 shows the embedded and polished cross-section of the metal sample, which was exposed with the corrosion probe at a 480 °C surface temperature and a flue gas temperature of 750 °C for 10 hours 30 minutes. Some areas (i.e., blue boxes) were analyzed by SEM/EDX. The Figure shows the BSE pictures of these areas. In the following sections, a selection of these areas is analyzed and evaluated in more detail.

Figure 5. Cross-section of the metal sample and areas with BSE images during the air combustion test

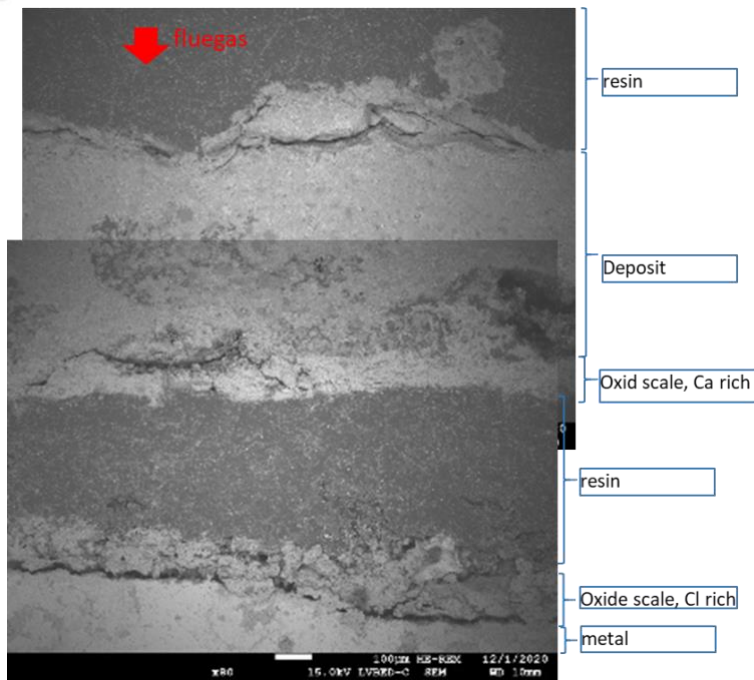
Figure 6 shows an overview of the deposit structure from transition material to deposit and deposit to embedding material (resin) at the “luv” side (flue gas). Since the deposit split off after removal of the pilot plant, there is another layer of embedding material between the oxide layer on the material and the deposit. For analysis, the off-cut pieces of deposition were reconstructed on the specimen again. The overview shows the different layers: attacked material, porous oxide scales, and compact deposit.

Figure 6. Overview of the deposit structure during the air combustion test

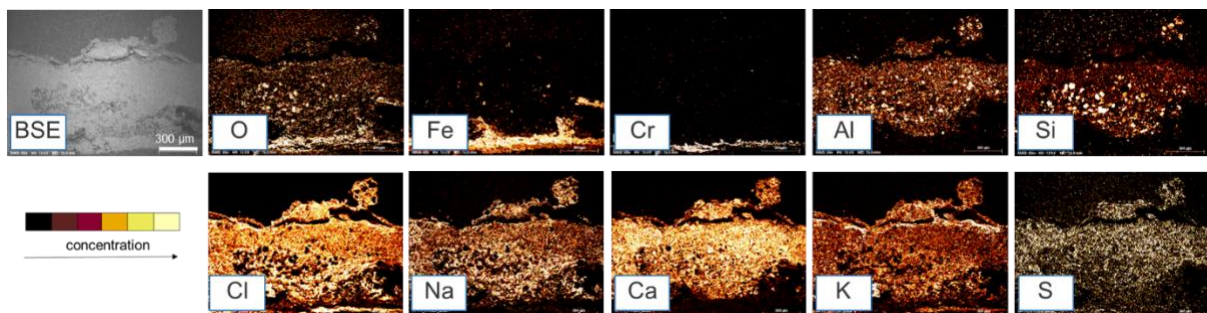
Figure 7 and Figure 8 show the element mappings of the areas shown in the middle of Figure 5 and Figure 6. The oxide scale is split into two layers. One adheres to the metal; the second part sticks to the deposit. Due to the high Cl content in the fuel of 0.49 wt%, the Cl was able to spread in the deposit and diffuse through the oxide layer to the pure metal surface. The alkalis Na, K and Ca, and also Al are homogeneously distributed in the deposit. Many small Si particles are embedded in the deposit. S is also found homogeneously distributed but in small amounts. Cl mainly compounds with K and Fe. Possible corrosive compounds: KCl, NaCl, CaCl₂, K₂SO₄, Na₂SO₄, CaSO₄.

These chlorine salts and the release of Cl₂ by sulfation can lead to the formation of FeCl_x below the porous oxide scale.

Figure 7. SEM/EDX element mappings; air combustion case; upper deposit part

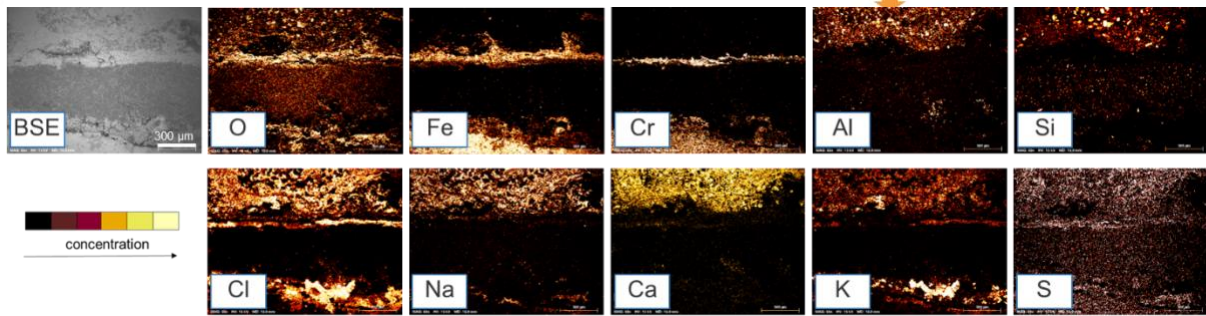
Figure 8. SEM/EDX element mappings; air combustion case; lower deposit part

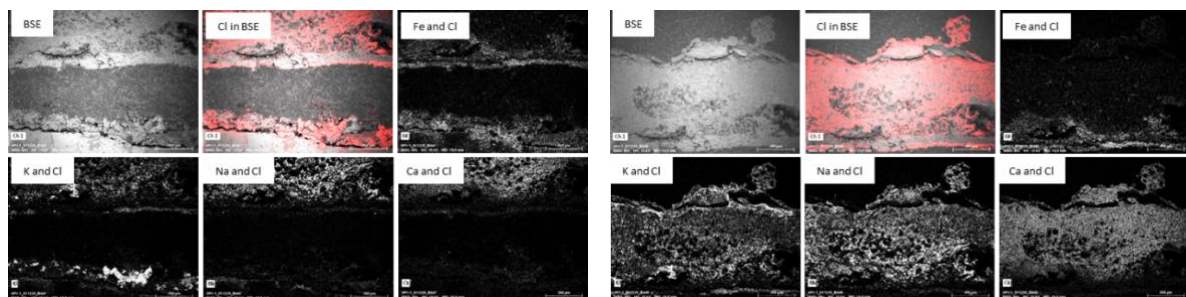
Figure 9 shows the compositions of the corrosive elements: Fe and Cl, K and Cl, Na and Cl, and Ca and Cl. The images show only the positions where the two selected elements are bound together. The corrosion front directly on the material surface is noticeable (FeCl_x and KCl). Alkali salts are homogeneously distributed in the deposit.

Figure 9. Compositions of the corrosive elements during the air combustion test: Fe+Cl, K+Cl, Na+Cl and Ca+Cl; left: lower deposit part; right: upper deposit part

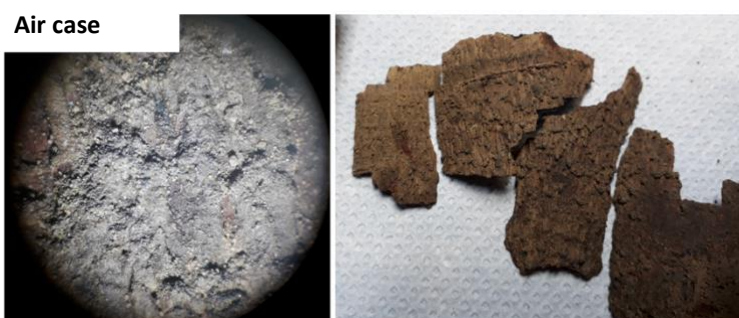
In the following section, the lower part of a split-off piece of deposit, which used to adhere to the surface of the material (**Figure 10**), is examined by SEM/EDX. The deposit could no longer adhere to the base material due to the formation of FeCl_x particles and the associated dissolution and splitting of the oxide layer. Cl and partially also S infiltrate the protective metal oxide layer and break it off both by reactions taking place, such as sulfation, between sulfates, chlorides, iron, and alkalis and by the increase in volume during the formation of solid iron chlorides. Furthermore, thermal stresses also affect the adhesion of the oxide layers and coatings when the probe is removed from the plant.

Figure 10. Part of deposit during the air combustion case

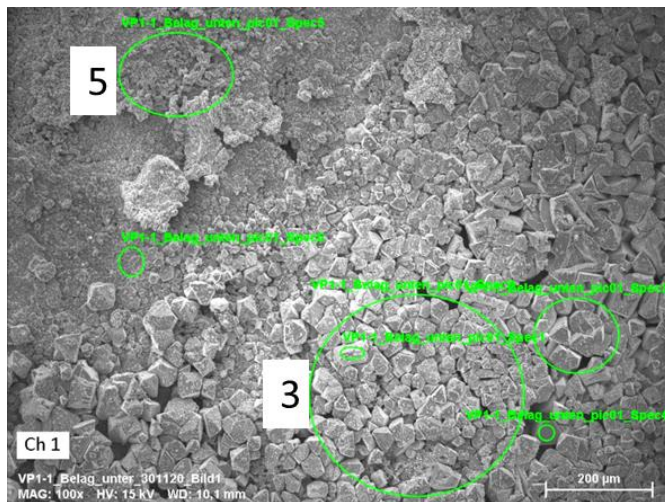
In **Figure 11**, you can see the underside of the deposit piece. The crystalline particles consisting mainly of Fe and Cl analyzed by SEM/EDX are clearly visible.

Figure 11. SEM/BSE of underside of the deposit piece; SEM/EDX spectra, underside of the deposit sample, Spectrum 3 and 5. Air combustion case

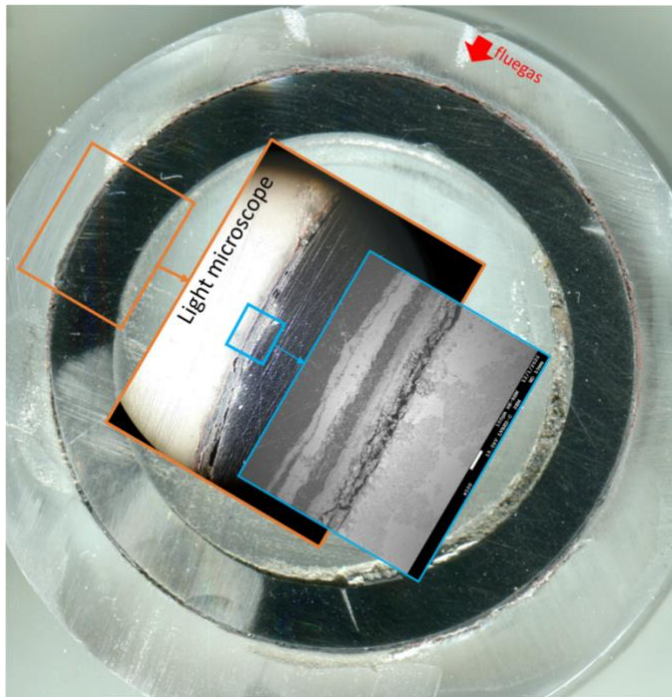
Figure 12 and Figure 16 show the embedded and polished cross-section of the metal sample, which was exposed with the corrosion probe at a 480 °C surface temperature and a flue gas temperature of 850 °C for 50 minutes. Some areas (blue boxes) were analyzed by SEM/EDX. The Figures show the BSE pictures of these areas. In the following sections, a selection of these areas is analyzed and evaluated in more detail.

Figure 12. Cross-section of the metal sample and analyzed area with BSE image at the OXY28 case

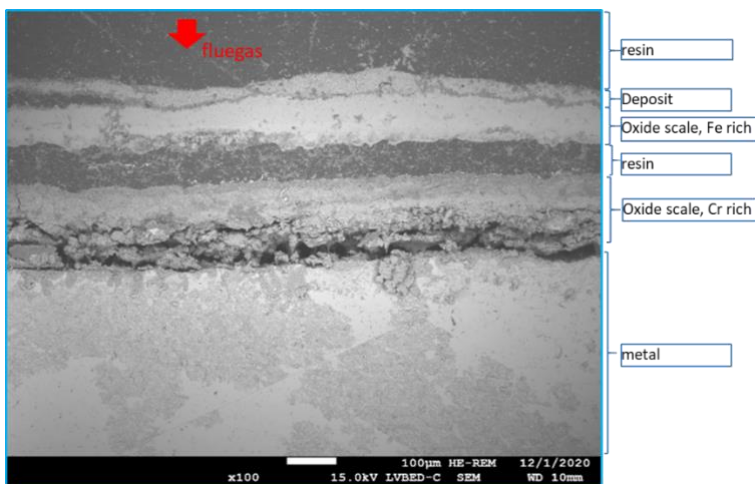
Figure 13 shows an overview of the deposit structure from transition material to deposit and deposit to embedding material (resin) at the “luv” side (flue gas). Since the deposit split off after removal of the pilot plant, there is another layer of embedding material between the oxide layer on the material and the deposit. The metal indicates attacks.

Figure 13. Overview of the deposit structure at the “luv” side during the OXY28 case

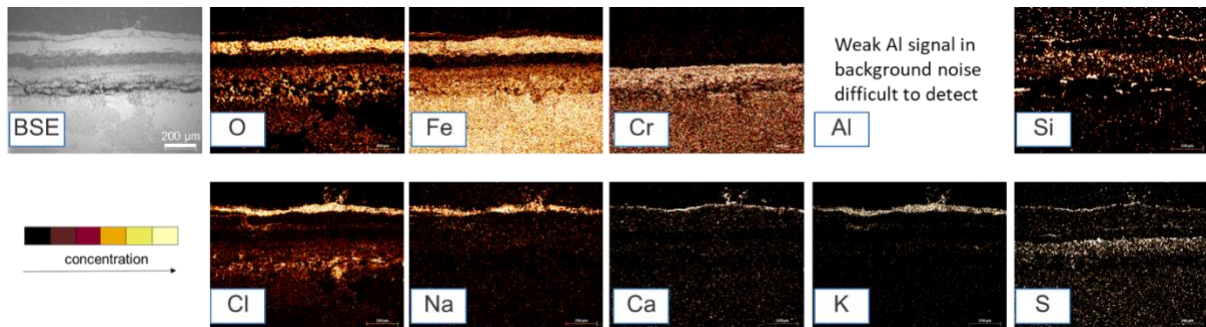
Figure 14 shows the element mappings of the areas shown in **Figure 12** and **Figure 13**. The oxide scale is split into two layers. One adheres to the metal; the second part sticks to the small deposit. Due to the high Cl content in the fuel of 0.49 wt%, the Cl was able to spread in the deposit and diffuse through the oxide layer to the pure metal surface. The alkalis Na, K, and Ca are homogeneously distributed in the deposit. Many small Si particles are embedded in the deposit. S is also found homogeneously distributed. Cl mainly compounds with K, Na Ca, and Fe. Possible corrosive compounds: KCl, NaCl, CaCl₂, K₂SO₄, Na₂SO₄, CaSO₄.

These chlorine salts and the release of Cl_2 by sulfation can lead to the formation of FeCl_x below the porous oxide scale. At the material surface, Cl is only found in combination with Fe. S is detected in the oxide scale. Here too, as in the sample from the air combustion case, spalling of the protective oxide layer occurs. Here it can be seen that the Fe oxide layer dissolves, while the Cr oxide layer appears more stable. However, this also begins to dissolve due to the penetration of Cl.

Figure 14. SEM/EDX element mappings at the “luv” side during the OXY28 case

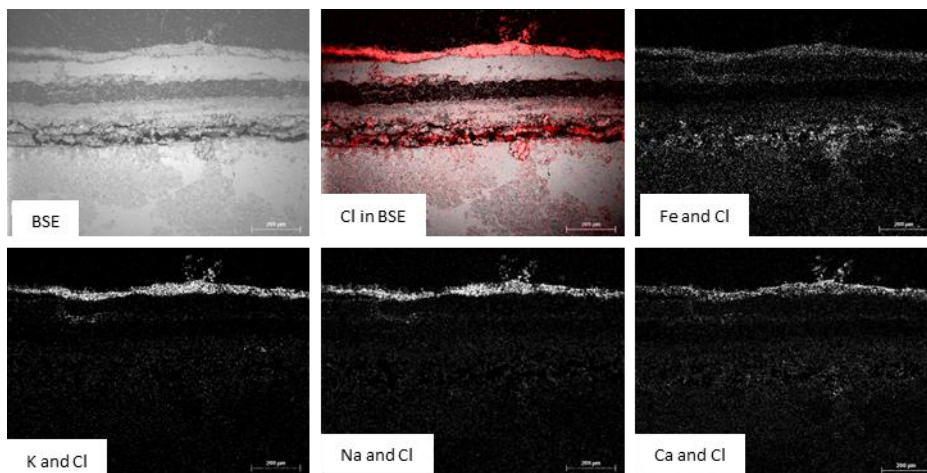
Figure 15 shows the compositions of the corrosive elements: Fe and Cl, K and Cl, Na and Cl, and Ca and Cl. The images show only the positions where the two selected elements are bound together. The corrosion front directly on the material surface is noticeable (FeCl_x). Alkali salts are homogeneously distributed in the small deposit.

Figure 15. Compositions of the corrosive elements at the “luv” side: Fe+Cl, K+Cl, Na+Cl and Ca+Cl; OXY28 combustion case

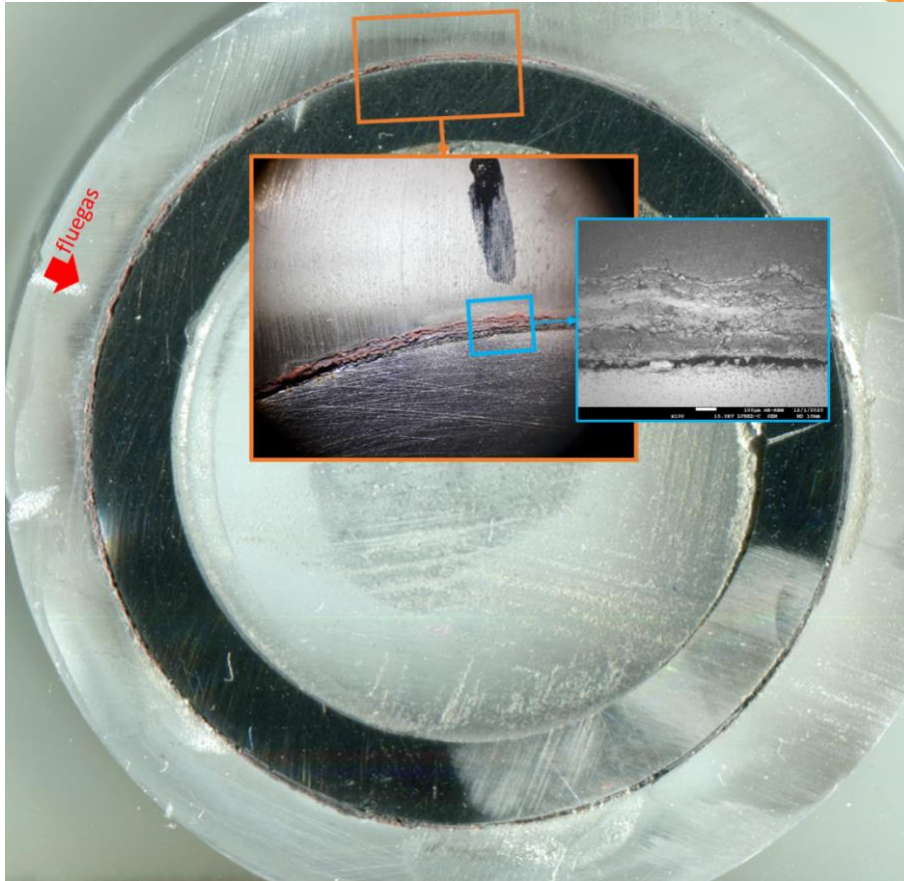
Figure 16 shows another position analyzed in the sample collected during the OXY28 case (i.e., sideways). A reddish layer can be seen in the light microscope image, which indicates the presence of hematite.

Figure 16. Cross section of the metal sample and analyzed area with BSE image; OXY28 combustion case

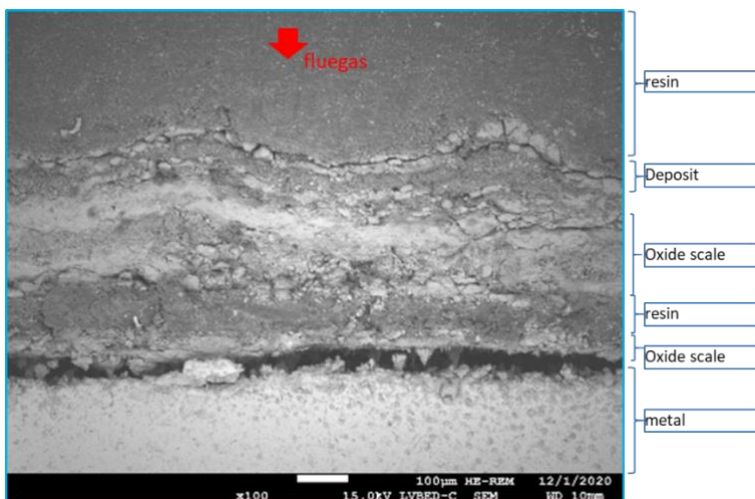
Figure 17 shows an overview of the deposit structure from transition material to deposit and deposit to embedding material (resin), sideways. Since the deposit split off after removal of the pilot plant, there is another layer of embedding material between the oxide layer on the material and the deposit. The deposit and oxides scale look very porous and broken.

Figure 17. Overview of the deposit structure at the OXY28 case, sideways

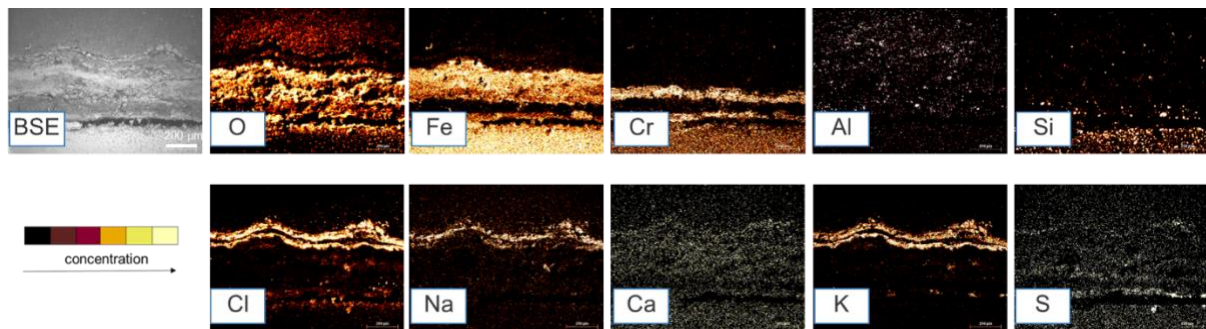
Figure 18 shows the element mappings of the areas shown in **Figure 16** and **Figure 17**. The oxide scale is split into two layers. A thick, iron-rich area represents the hematite interspersed layer.

Another, Cr-rich zone, adheres to the metal. After a short time of only 50 minutes, FeCl_x particles are found in the gap between the material surface and the oxide scale. The alkalis Na and K are homogeneously distributed in the small deposit. Ca was found homogeneously distributed together with S in small amounts in deposit and oxide scale. Cl mainly compounds with K, Na, and Fe. Possible corrosive compounds: KCl, NaCl, CaSO_4 .

These chlorine salts and the release of Cl_2 by sulfation can lead to the formation of FeCl_x below the porous oxide scale. At the material surface, Cl is only found in combination with Fe. S is detected in the oxide scale.

Figure 18. SEM/EDX element mappings during the OXY28 case, sideways

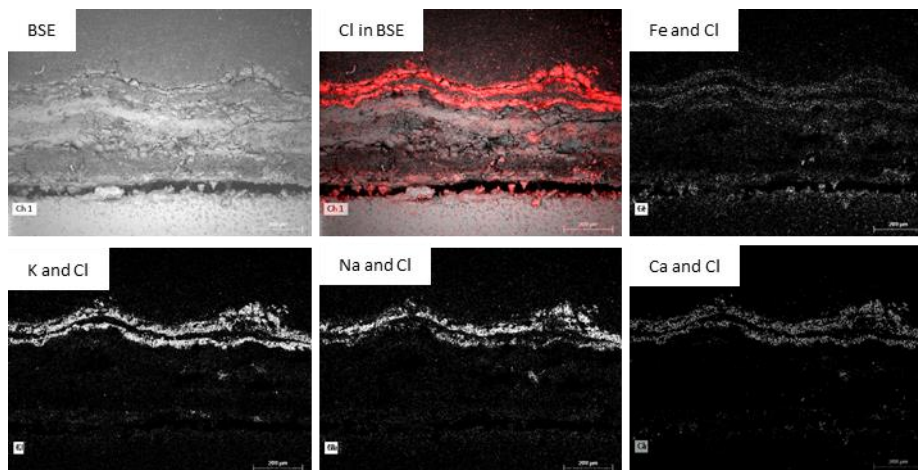
Figure 19 shows the compositions of the corrosive elements: Fe and Cl, K and Cl, Na and Cl, and Ca and Cl. The images show only the positions where the two selected elements are bound together. The corrosion front directly on the material surface is noticeable (FeCl_x). Alkali salts are homogeneously distributed in the small deposit.

Figure 19. Compositions of the corrosive elements during the OXY28 case, sideways: Fe+Cl, K+Cl, Na+Cl and Ca+Cl
