Results of corrosive depositions on super-heater pipes

Author: Joseba Moreno, Eva Miller, Max Schmid

Date: 08 February 2022

ACT2 NEWEST-CCUS project No 299683

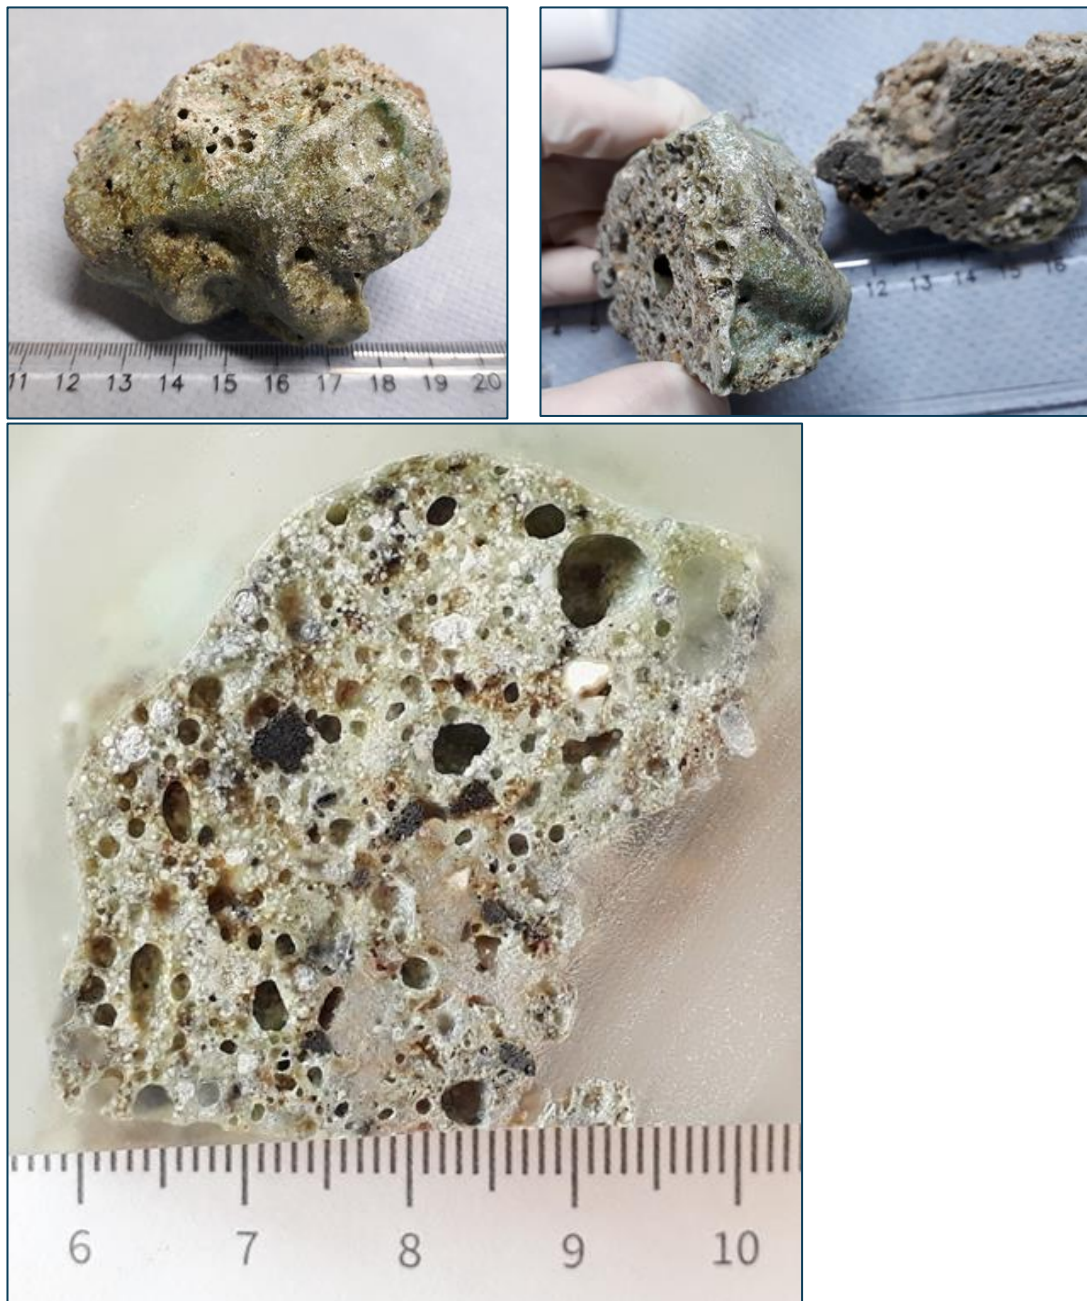
Slag samples were taken after the OXY28 combustion test from the bottom ash of the CFB combustor. One of the samples was prepared as cross-section for electron microscopic image analysis (Figure 20). The chemical composition of such slag sample is given in Table 3.

Figure 20. Piece of slag out of bottom ash after the OXY28 combustion test

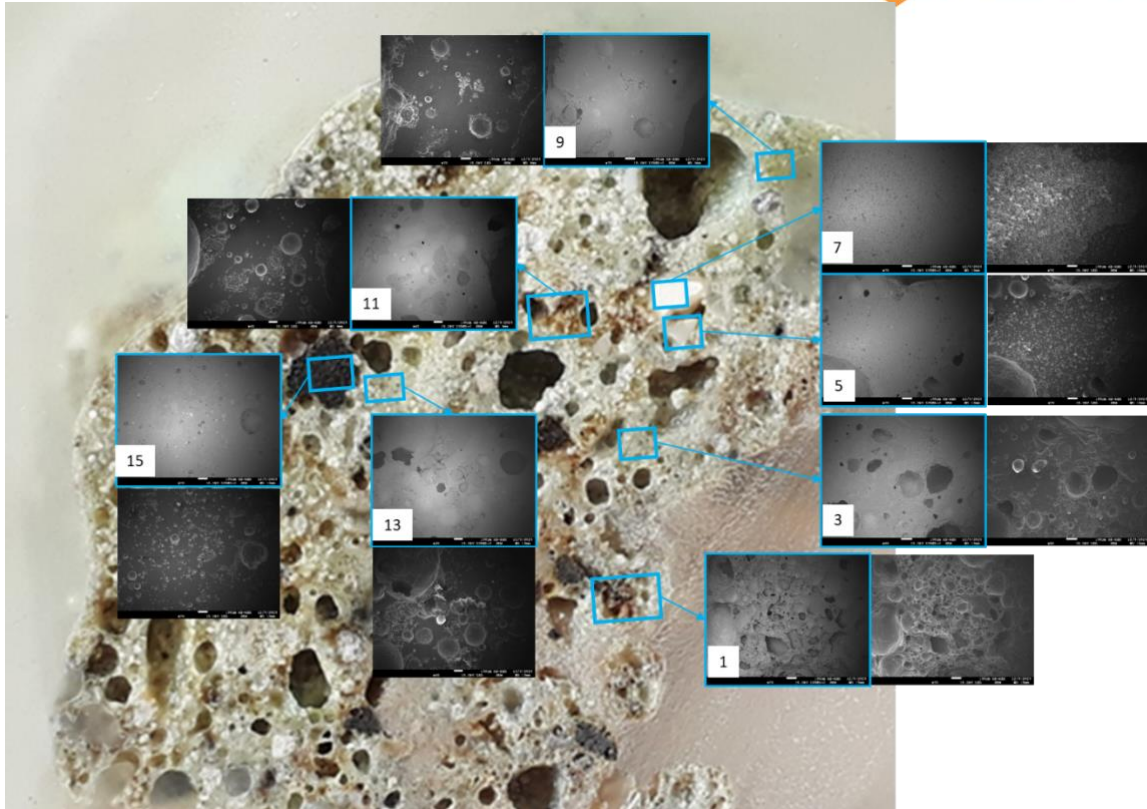
Figure 21 shows the embedded and polished cross-section of the slag sample, which was sampled at the bottom ash container of the CFB combustor at the OXY28 test with a flue gas temperature of 850 °C. Some areas (blue boxes) were analyzed by SEM/EDX. The Figures show the BSE and SE pictures of these areas. In the following sections, a selection of these areas is analyzed and evaluated in more detail.

Figure 21. Cross section (and analyzed areas with BSE images) of the slag sample after the OXY28 combustion case

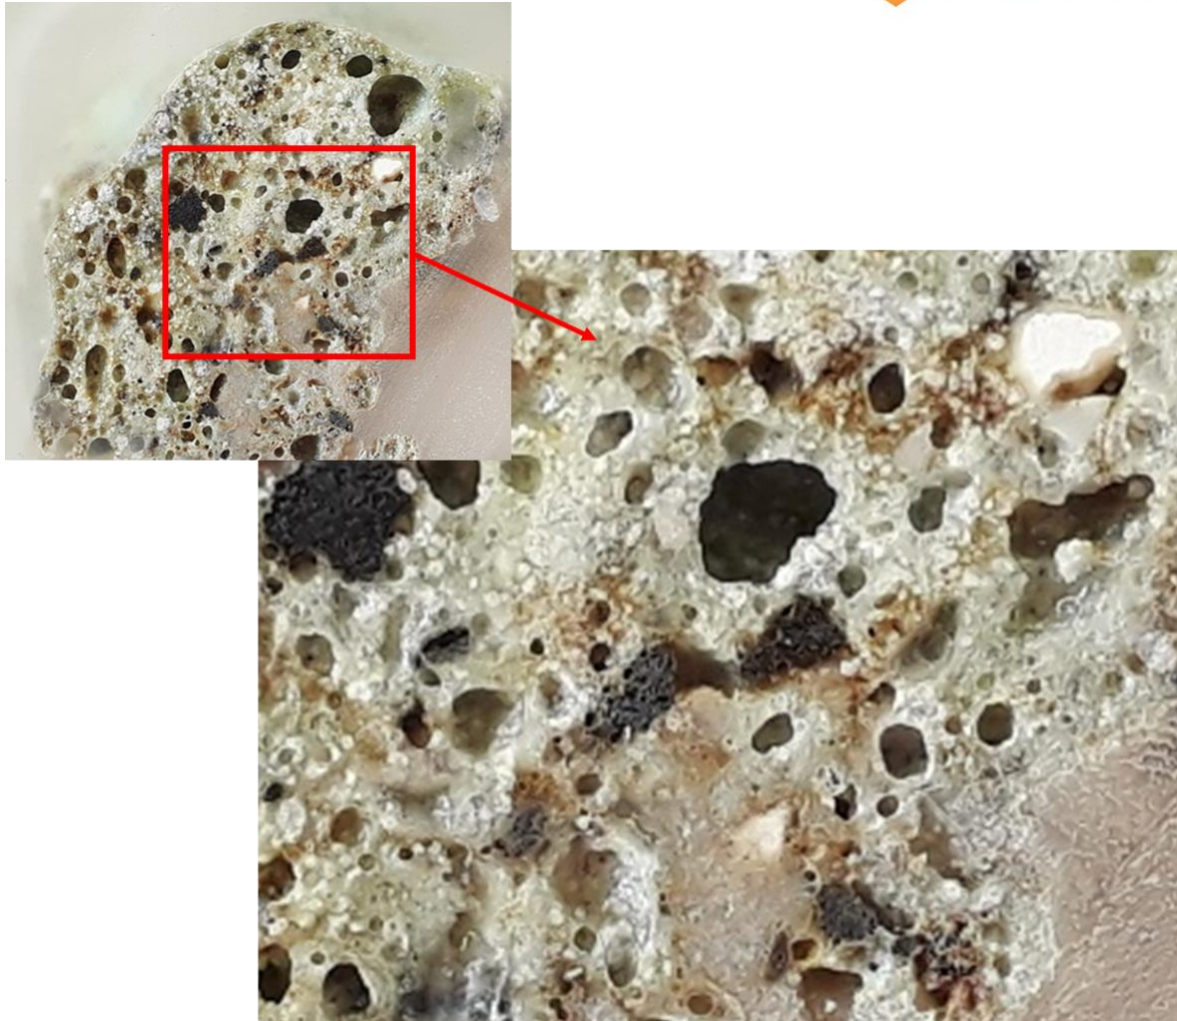
Figure 22. Detail image of the slag sample, optical structure

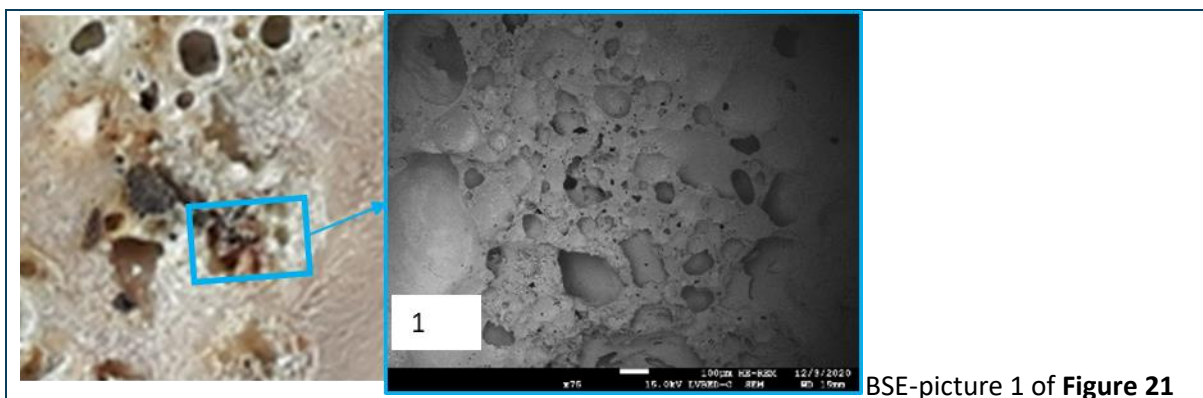
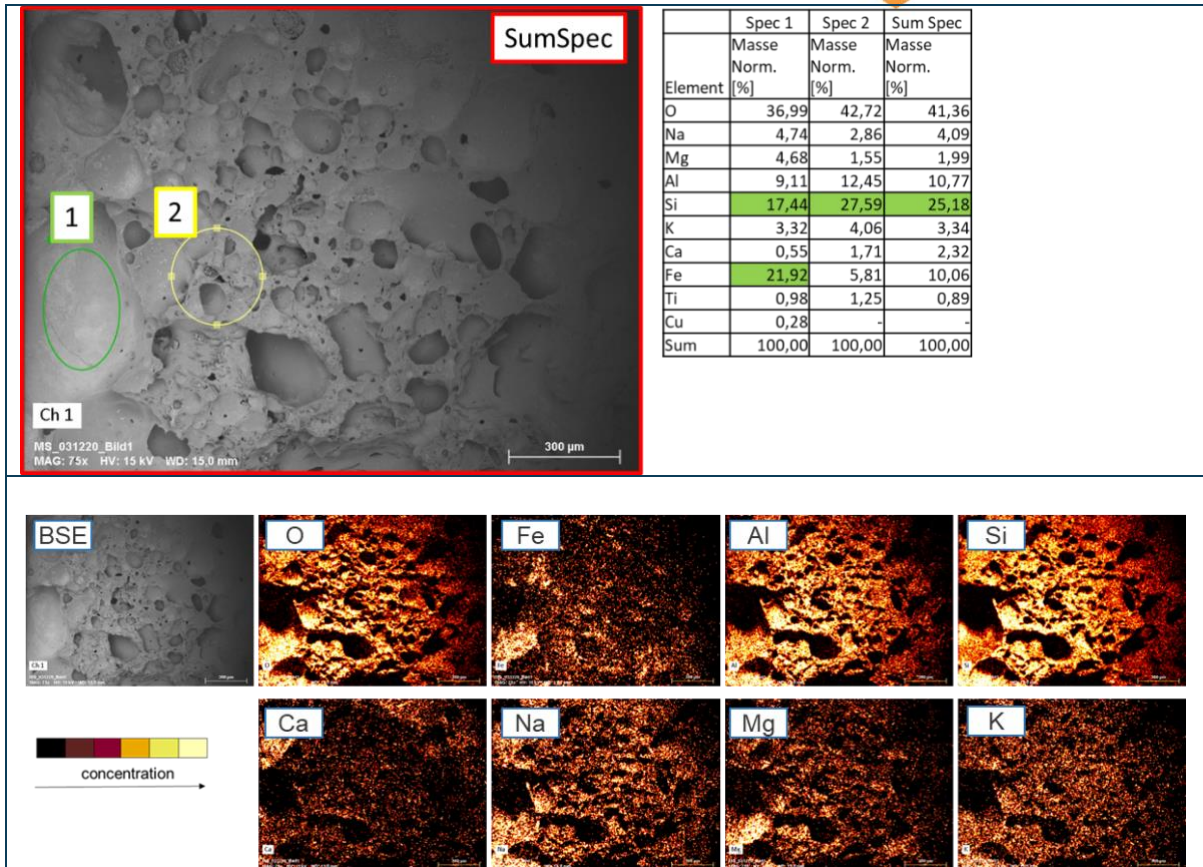
BSE-picture 1 of **Figure 21**

Figure 23 presents the results of a brownish area (number 1 in Figure 21) in the slag. This area is characterized by pores. The elements are homogeneously distributed. The two spectra show a high amount of Si and O, some Al, and a low amount of the alkalis Na, K, Ca, and also Mg. Spectrum 1 also shows a high proportion of Fe.

Figure 23. SEM/EDX results of the brownish area (number 1 in Figure 21) in the slag; above: BSE picture; middle: Spectra of two small areas (green 1 and yellow 2; semi-quantitative); below: element mappings

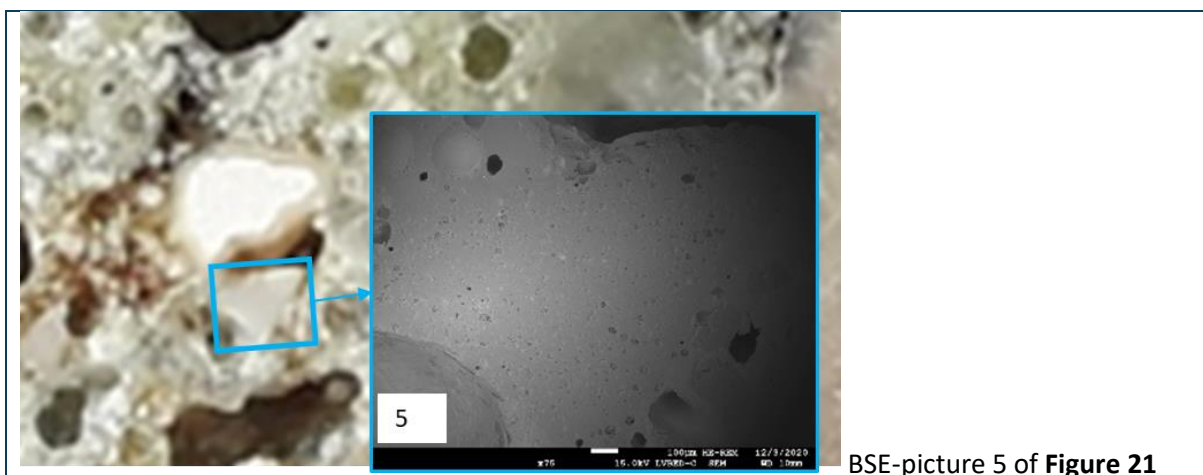
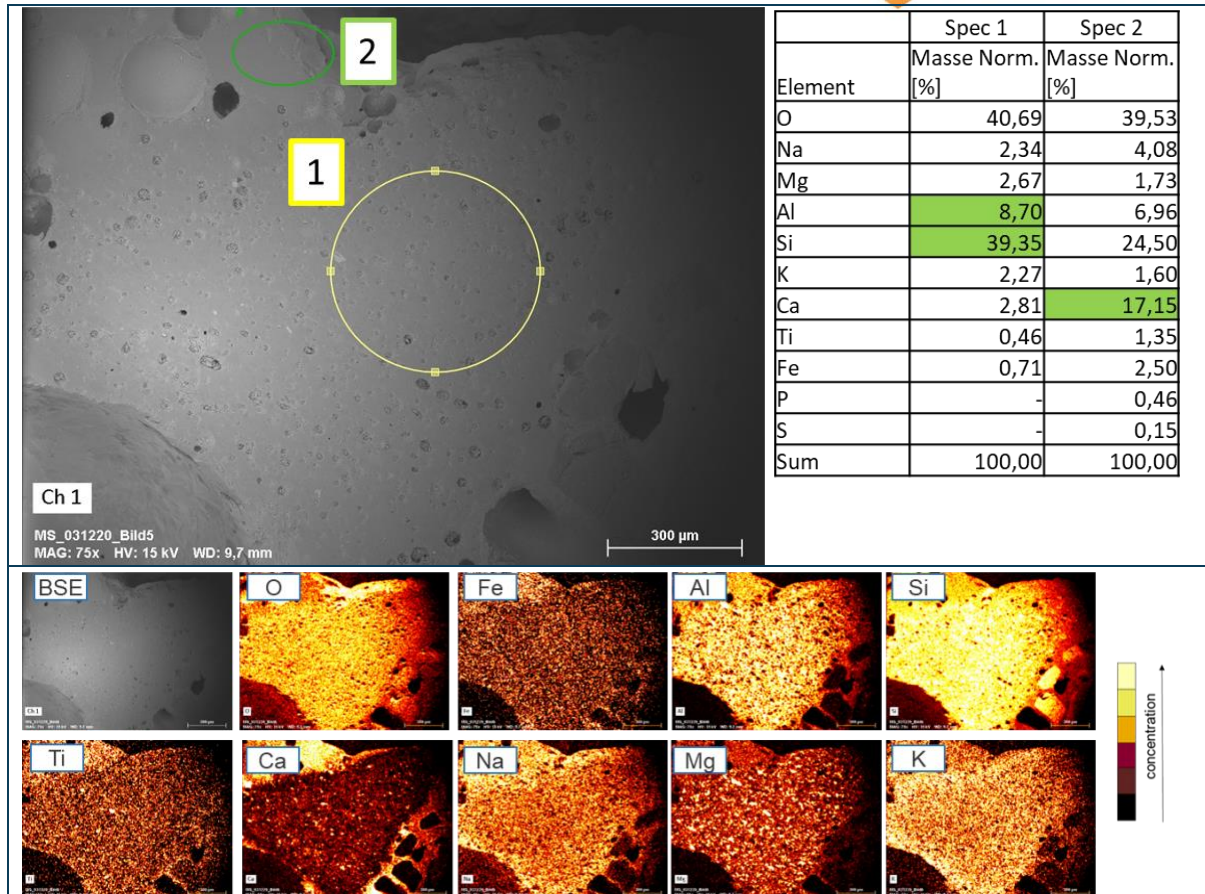
BSE-picture 5 of Figure 21

Figure 24 presents the results of area 5 in Figure 21 in the slag. This area shows a compact pore-free particle. The elements are homogeneously distributed (spectrum 1). To the side of the particle, a different composition (spectrum 2) can be seen. Spectrum 1 shows a high amount of Si and O, some Al, and a low amount of the alkalis Na, K, Ca, and also Mg. Spectrum 2 also shows a high amount of Ca, which indicates the presence of CaO.

Figure 24. SEM/EDX results of area 5 in **Figure 21** in the slag; above: BSE picture; middle: Spectra of two small areas (green 2 and yellow 1; semi-quantitative); below: element mappings

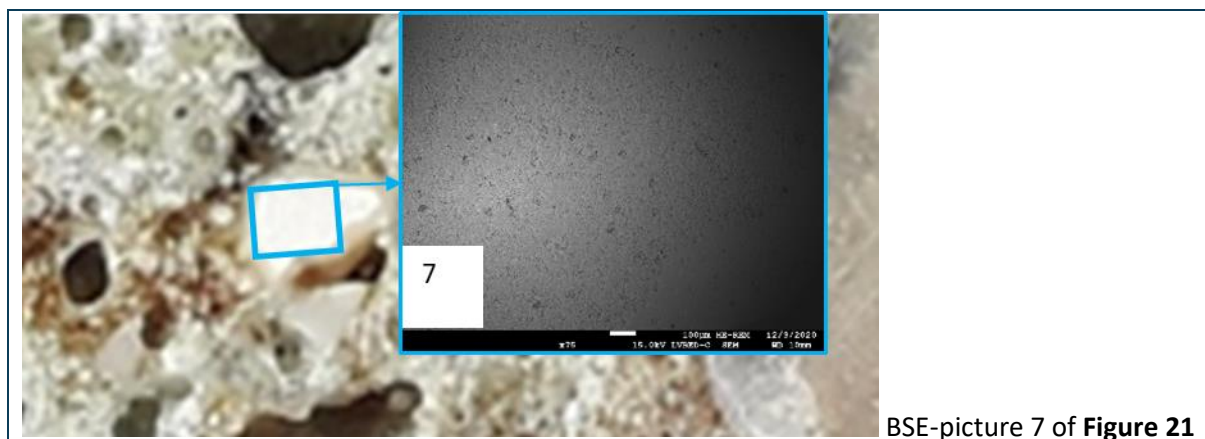
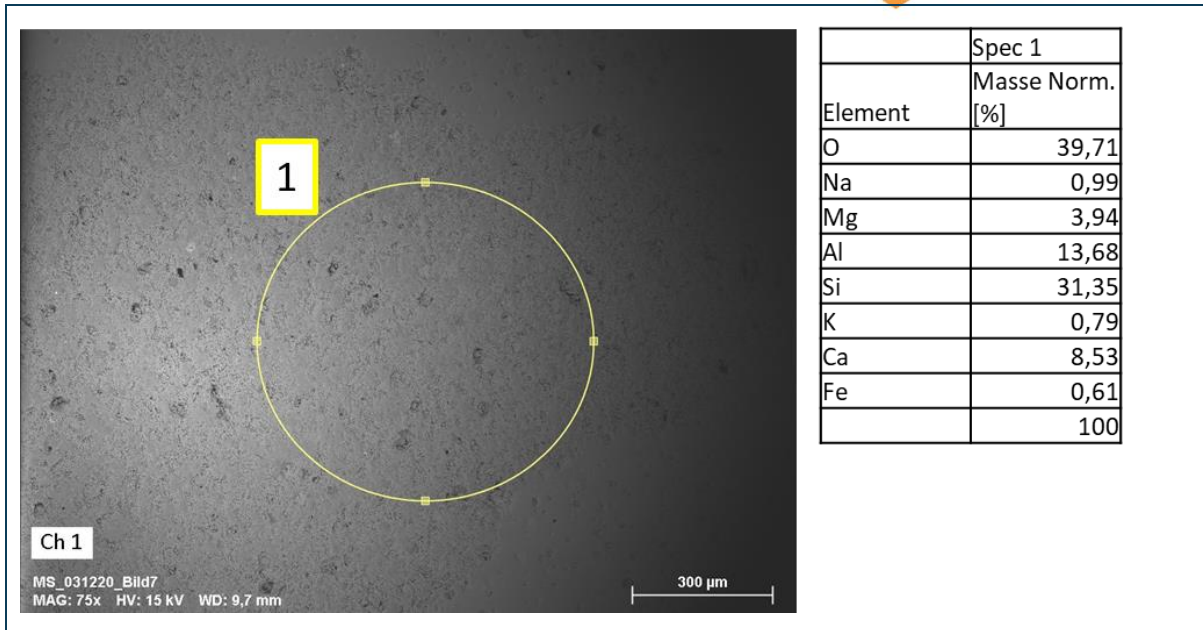
BSE-picture 7 of **Figure 21**

Figure 25 presents the results of a white area (number 7 in **Figure 21**) in the slag. This area shows another compact pore-free particle. The elements are homogeneously distributed. Spectrum 1 shows again a high amount of Si, O, and Al and a low amount of the alkalis Na, K, and also Mg. Ca is present in a higher amount than the pore-free particle in **Figure 24** (Spec 1).

Figure 25. SEM/EDX results of a white area (number 7 in Figure 21) in the slag; above: BSE picture; below: Spectrum of one area (yellow 1; semi-quantitative)

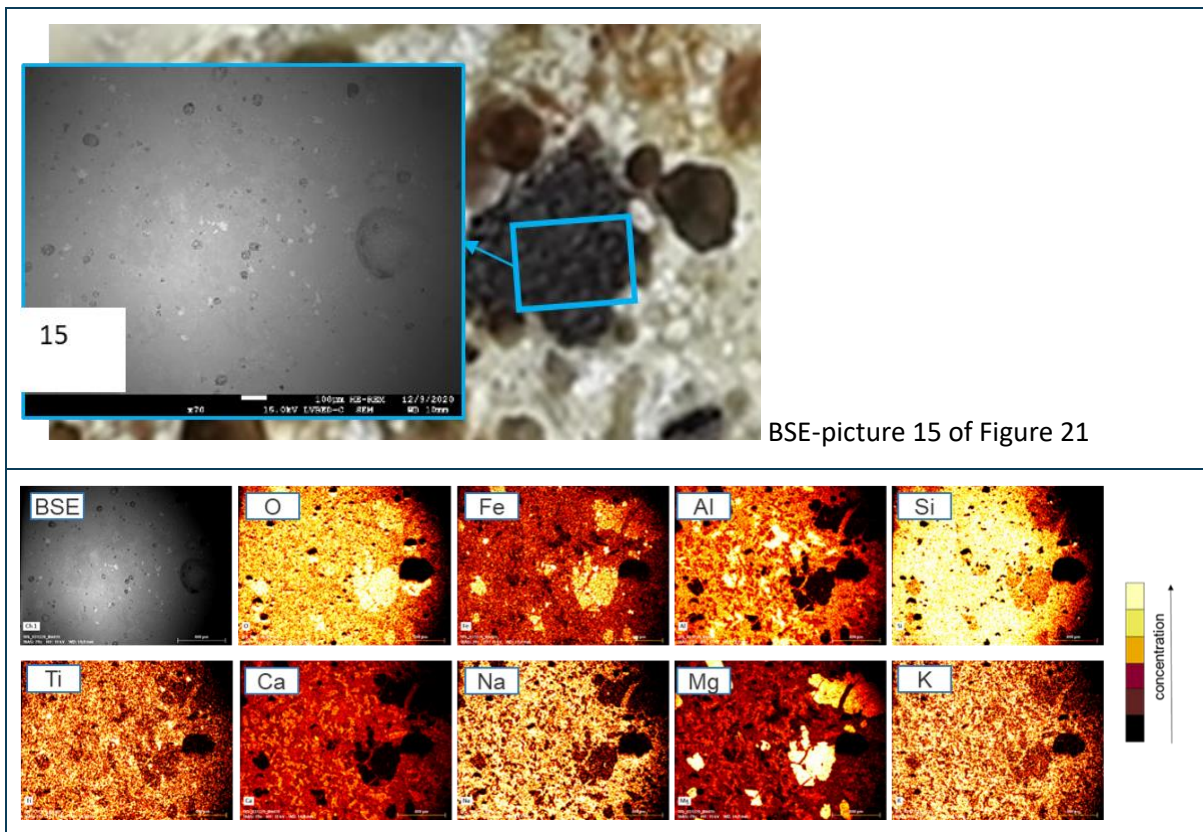
Figure 26 presents the results of a black area (number 15 in Figure 21) in the slag. In this area, the elements are homogeneously distributed (O, Al, Si, Ca, Na). Some areas show a higher amount of Fe, Mg, and O.

Figure 26. SEM/EDX results of a black area (number 15 Figure 21) in the slag; above: BSE picture; below: element mappings
